Experimental investigation of thermal shock effects on carbon–carbon composites

Alma L. Leanos, Pavana Prabhakar*

Department of Mechanical Engineering, University of Texas at El Paso, El Paso, TX 79968, USA

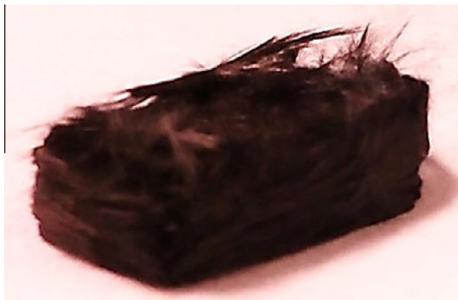
Fig. 7. 1000 °C 2D C/C composite test specimen (3 cycles) showing fibers separating from the surface.

Test specimens exposed to three cycles of thermal shock at different peak temperatures are shown in Fig. 6(a) to (c). It can be noticed that further oxidation occurred at the exposed lateral surfaces of the composite with increasing number of thermal cycles. For instance, further oxidation at the lateral surfaces of test specimens exposed to 400 °C and 600 °C resulted in a reduction of visible voids and cracks, as shown in Fig. 6(a) and (b). Nevertheless, the carbon matrix at the surface degraded further by increasing the number of thermal cycles that resulted in the fibers to separate from the surface, as shown in Fig. 6(c) for 700 °C and Fig. 7 for 1000 °C test specimens (3 cycles).

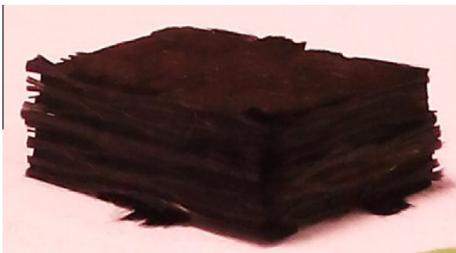
Fig. 14. 700 °C 2D C/C composite test specimen after compression test showing shear mode of failure.
